Region 5

Coordinated Effort Improves Plant Operation

Sandwich WWTP, Illinois

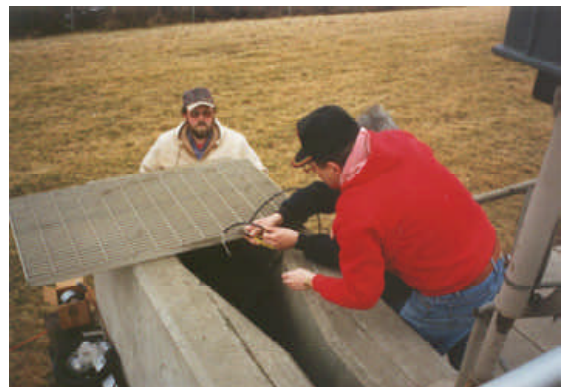
Chlorine addition at the Sandwich WWTP controls filamentous bacteria.

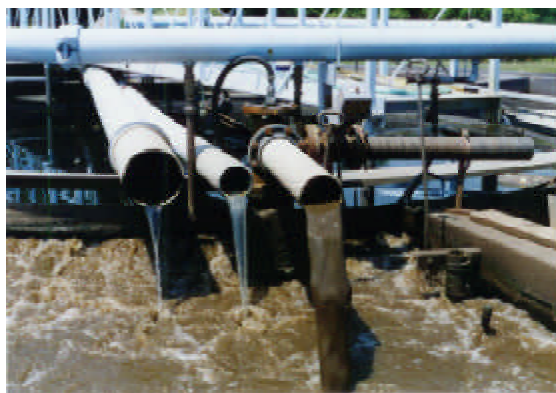
Operations personnel re-piped the plant influent and automated the activated sludge wasting process. These changes improved effluent quality and reduced operator time at the plant. The city of Granville saved money on both.

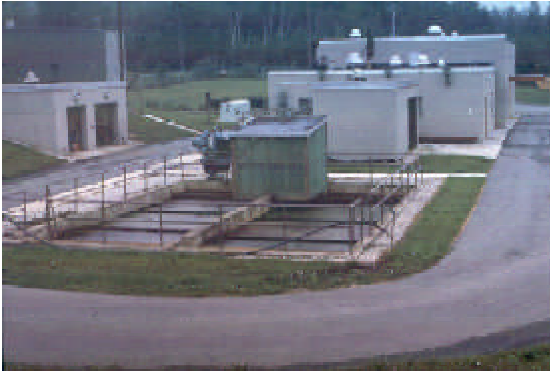
Primary clarifiers at the Newberry WWTP, where technical assistance greatly enhanced process control.

The 104(g)(1) technical assistance provider determined that the primary reason for the non-compliance was the development of filamentous organisms in the plant's secondary system. Poor control of secondary sludge return flows, inconsistent control of wasting, poor solids handling practices, and periodic equipment failures were all found to be contributing to the plant's problems.

The situation was immediately improved by the eradication of the filamentous bacteria and by improved control practices. The length of the 104(g)(1) assistance was extended because of plant personnel problems, including the replacement of the superintendent twice. The new superintendent was instructed in proper control practices and gained a good understanding of process control, the application of secondary control practices, proper solids handling procedures, and the importance of a good preventive maintenance program. As a result of only four 104(g)(1) visits to the plant and a couple of dozen phone calls, the facility's effluent biochemical oxygen demand and suspended solids are now consistently below 10 mg/L, just one-third of the permit limit. All other permit limits are also being met.

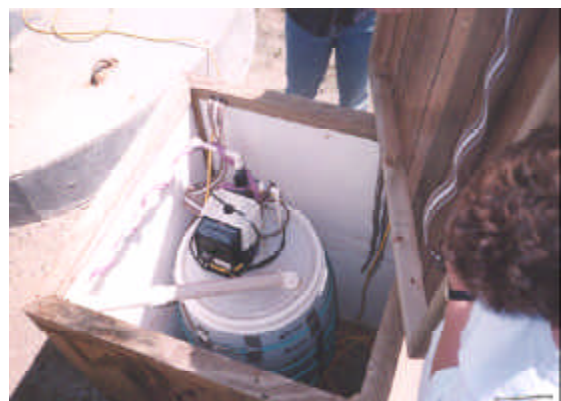
A temporary ferric chloride feed system was installed between the fourth and fifth lagoons to reduce the phosphorus concentrations at the Carson City WWTP.

Michigan's Surface Water Quality Division referred the situation to Doug Hill, a 104(g)(1) assistance provider with Michigan's Department of Environmental Quality's Operator Training Unit. In late 1992, Hill coordinated jar testing on samples at the five-cell lagoon system to determine a better point for phosphorus removal than the first-cell application. At Hill's recommendation, in the summer of 1993, a temporary ferric chloride feed system was installed between the fourth and fifth lagoons. The phosphorus concentration dropped throughout the summer, and by the fall, the phosphorus level was well under the facility's 1 mg/L limit.

The temporary feed system was replaced with a permanent line, and the plant has been in compliance with the discharge permit from that time to the present.

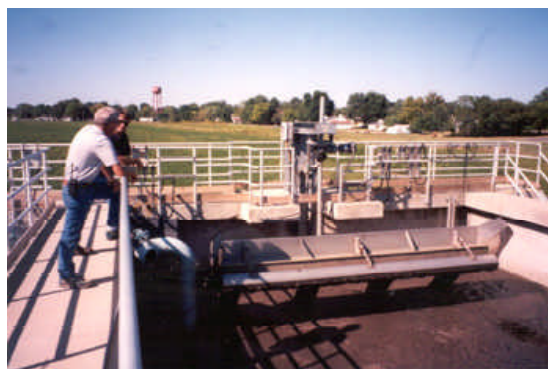
Jim Borton and Plant Superintendent discussing process control by SBR at Richwood WWTP.

Through the 104(g)(1) Operator Assistance Program, Jim Borton of Ohio’s Environmental Protection Agency Compliance Assistance Unit evaluated the system’s problems and prioritized its needs to bring it back into compliance as quickly as possible. Borton, working with the highly motivated village officials, concentrated on intensive operator training, while coaching village officials on appropriate steps they could take to assist in the plant’s recovery.

Borton also noted that the facility suffered from infiltration and inflow problems, especially during rain events, when flow levels sometimes more than tripled. Borton’s recommendations concerning this issue helped the village qualify for and receive a \$225,000 state

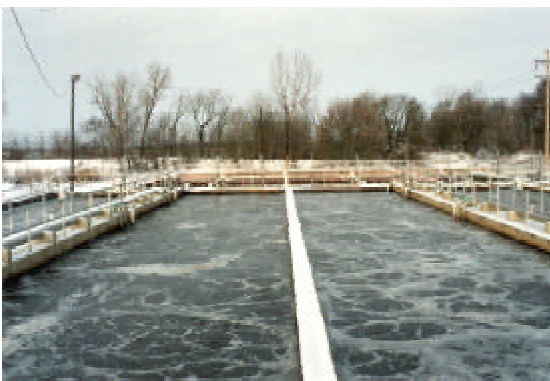
Activated sludge basins at Fostoria WWTP.

Ankrom's initial evaluation found that, despite recent upgrades, the WWTP was experiencing significant loss of solids, as well as difficulty in achieving complete nitrification. It was determined that the nitrification and suspended solids problems resulted from "starvation" of the activated sludge biomass. Essentially, the primary clarifiers and trickling filters were removing too much organic waste, which is food for the biomass.

Ankrom suggested an alteration to the system that would allow the development of the proper biomass in the activated sludge system.
